Asteroid explorer, Hayabusa2, reporter briefing

July 25, 2017

JAXA Hayabusa2 Project

- Results from the 2nd touchdown operation

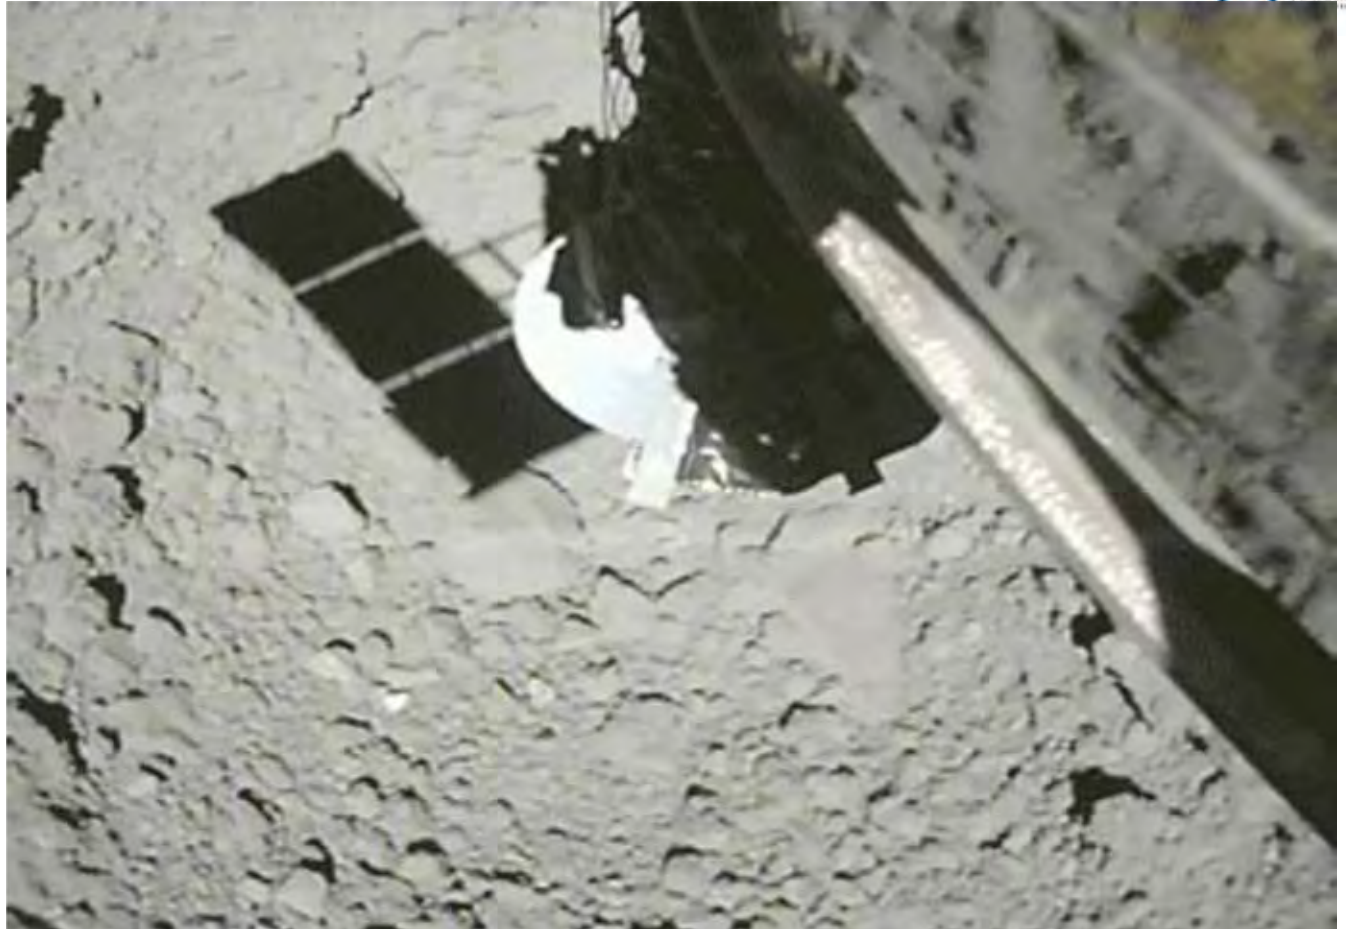
Images from the small monitor camera (CAM-H).

Images before and after touchdown
(10x animation)

Capture time:

2019/7/11

Start 10:03:54 (altitude 8.5m)

Finish 10:11:44 (altitude 150m)

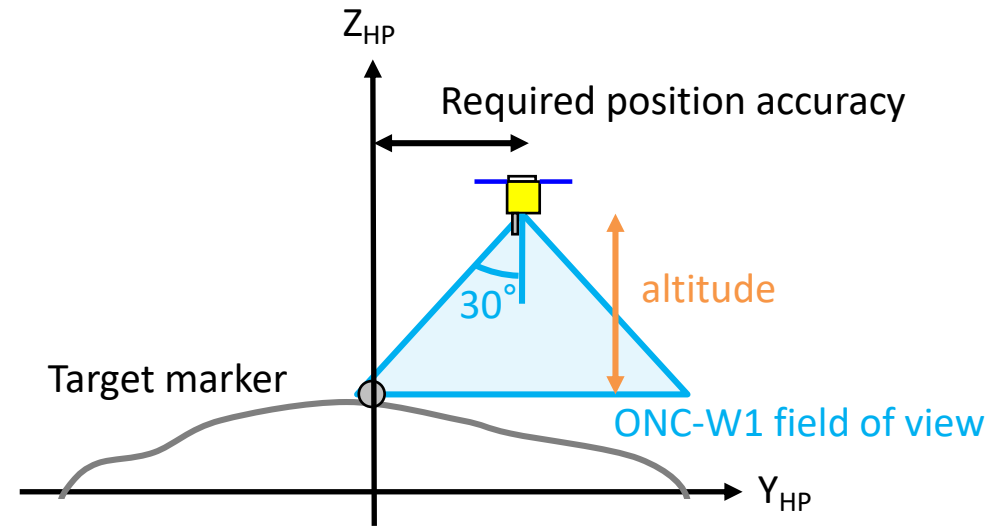
Position accuracy required for target marker capture

Alt.	Required position accuracy	Remarks
30 m	$\tan(30^\circ) * 30 = 17 \text{ m}$	When the altitude is as planned
20 m	$\tan(30^\circ) * 20 = 11 \text{ m}$	When altitude is 10m lower

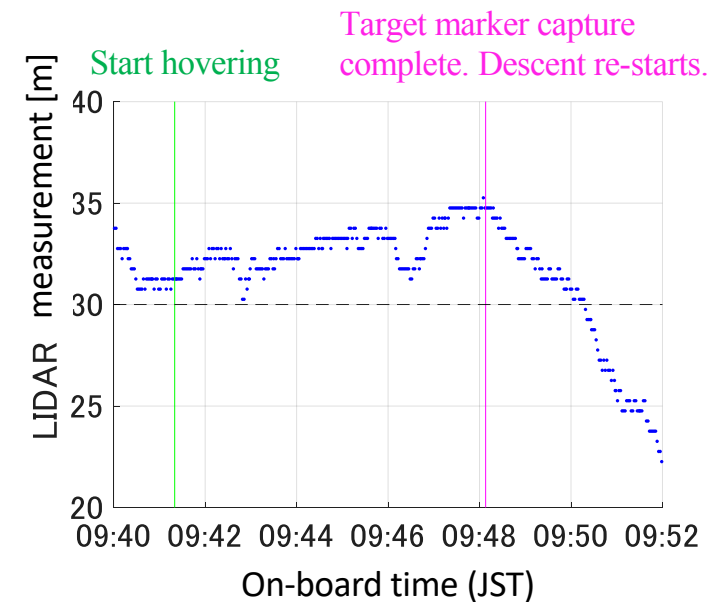
Result (descent orbit • hovering altitude)

Final position error in the horizontal direction (X, Y, direction) is estimated to be 3m or less, and the final position error in the altitude (Z direction) is 5m or less. Target marker capture was successful.

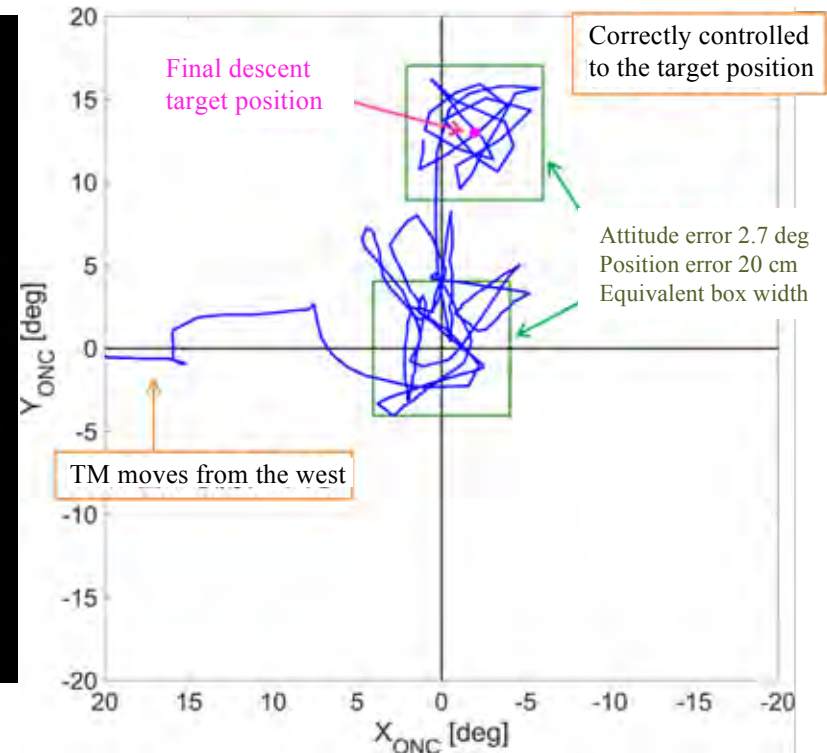
DBT/NBT image and target marker tracking

DBT (Differential Bright object Tracking)
: image actually used by the spacecraft for measurement

NBT (Normal Bright object Tracking)
: similar image not used for actual measurement (reference)

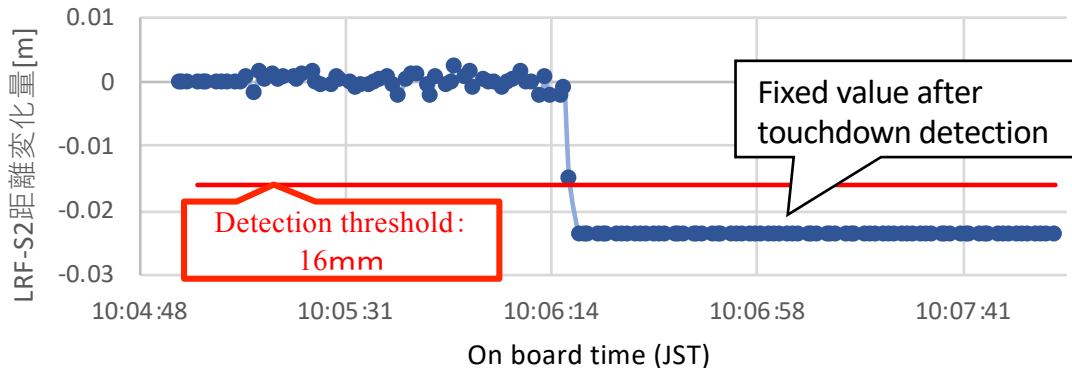
- The final descent ΔV for touchdown was performed at an altitude of 8.5m. Touchdown detection was enabled 50 seconds after the final descent ΔV . Then touchdown occurred on the asteroid surface. Touchdown was judged by **detecting the change in distance with the LRF-S2**, which measures the distance to the tip of the sampler horn that compresses slightly during touchdown.

- After touchdown detection, **the sequence for firing a 3rd projectile, followed by the sampling sequences, were performed**. An ascending ΔV then caused the spacecraft to rise and leave the asteroid surface.

- As vibration in the sampler horn is generated by the final descent ΔV , the sequence was devised so as not to generate unnecessary sampler horn vibration.

- At the time of touchdown, the ‘tail-up’ posture is adopted around the Y-axis to prevent collision of the spacecraft with the boulders and other protrusions, based on the prediction of the spacecraft behaviour.

LRF-S2 measurements before and after touchdown detection

Time (s)	On-board time (JST)	Event
-60		Final altitude control begins
0	10:04:55	Final descent ΔV begins
15		RW attitude control begins (sampler horn vibration prevention measures)
50		Touchdown detection judgement begins
~70		Posture convergence
82-84	10:06:17-19	Touchdown detection
82-84	10:06:17-19	Sampling operation (Projectile launch etc.)
82-84	10:06:17-19	Rising ΔV begin
94		RCS attitude control transition

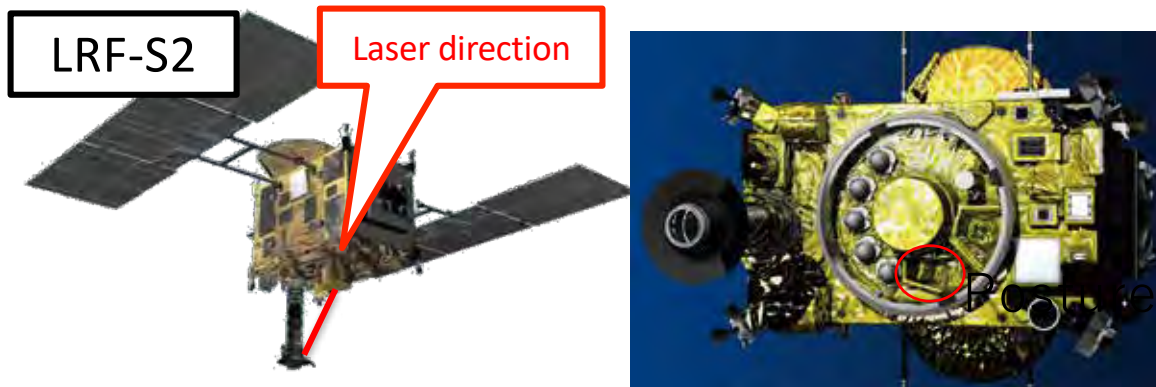
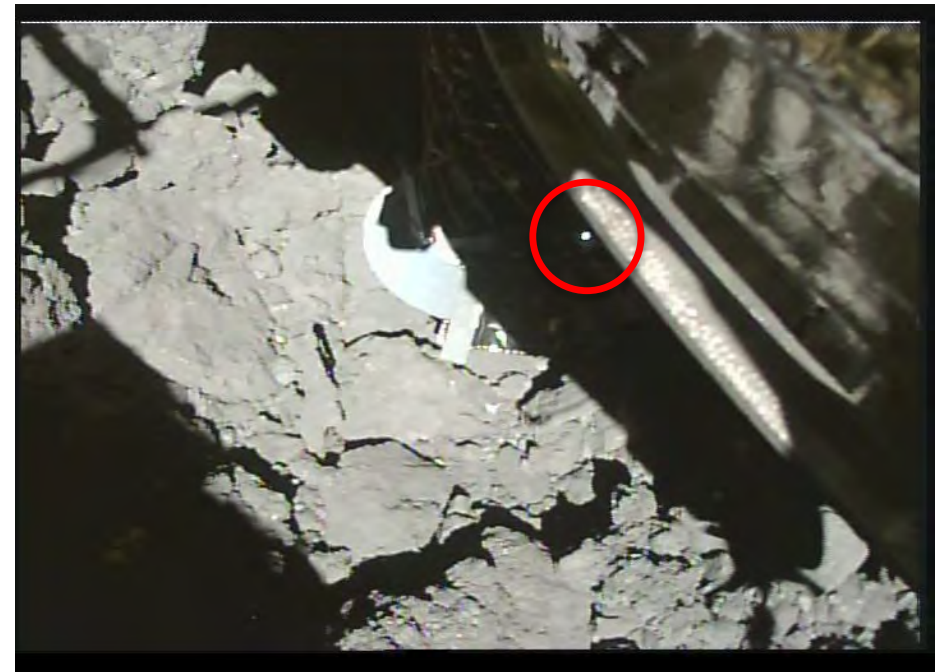
- The LRF-S2 emits a laser towards a reflector attached to the tip of the sampler horn.
- This measures distance and intensity value.

Laser light from the LRF-S2 imaged by CAM-H
(At the 2nd touchdown)

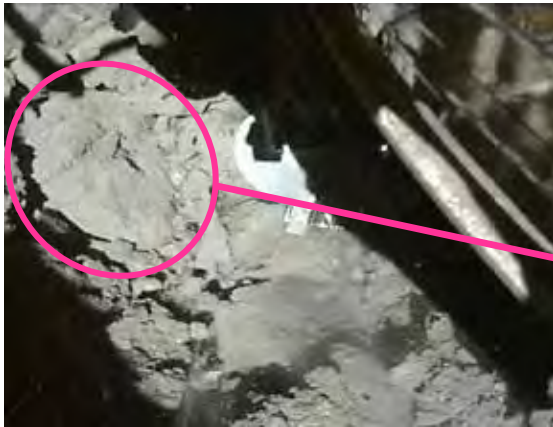
2nd touchdown sampler horn ground point

CAM-H images

Consistent with CAM-H image

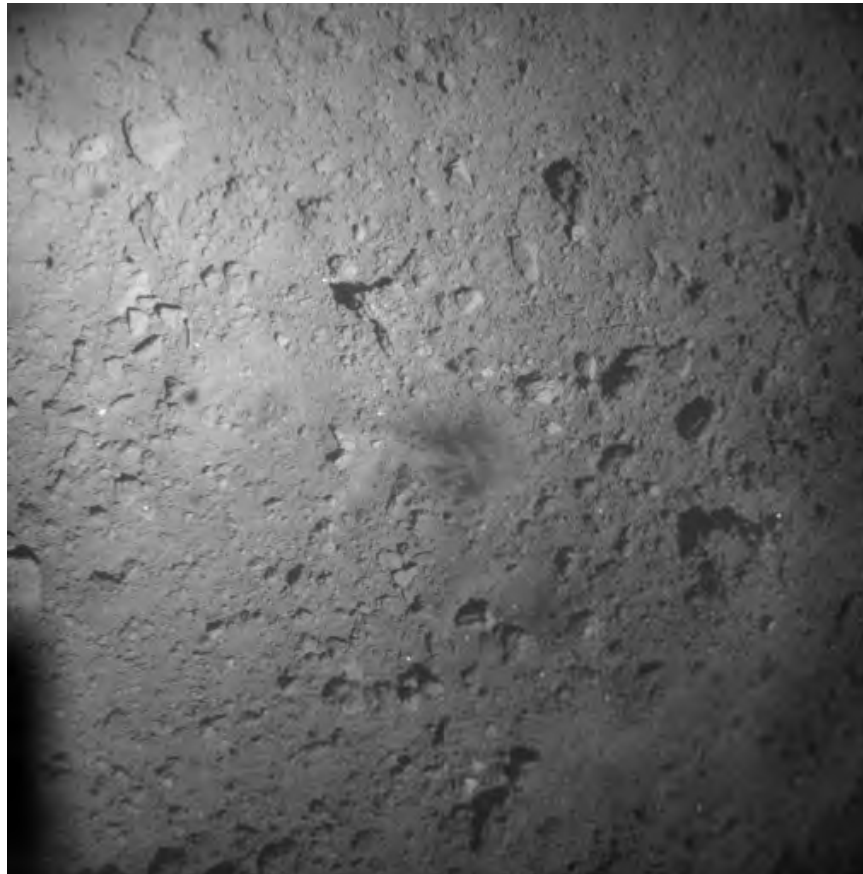
Images from the ONC-W1

2019/7/11

10:08:53 JST (on-board time)

Altitude: about 90m
